## Castlebanny Wind Farm

342068

Thursday, 23 January 2020

15 Locations Assessed

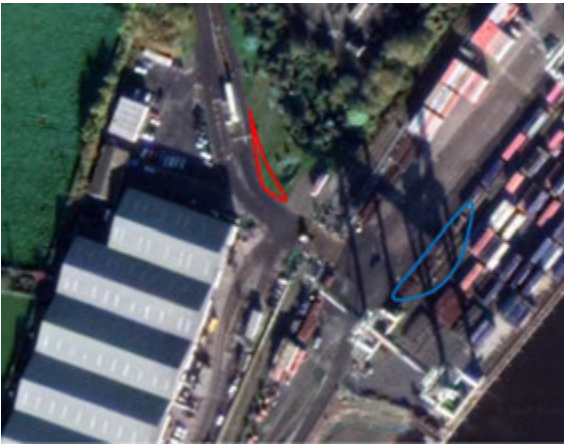
## Location 1 - Exit Port Of Waterford

Visual inspection indicates that loaded blades will require to contra flow the security building and oversail land on offside.

Road widening will be required as per the red hatching shown on grass verge.

Blade tips will require to oversail area shown on Ariel mapping as indicated by blue hatching.

It is recommended that the new fencing within the port near blue hatching is made removable to assist navigation.

A topographical survey and swept path analysis is recommended at this location to confirm exact modifications required.

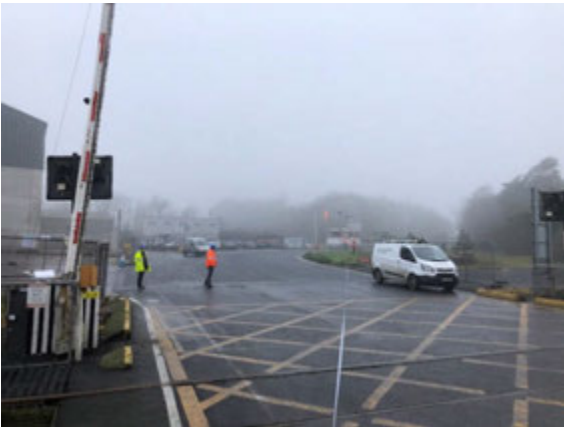
## Location 1 Continued - Exit Port Of Waterford

Road widening will be required as per the red hatching shown on grass verge.

A topographical survey and swept path analysis is recommended at this location to confirm exact modifications required.

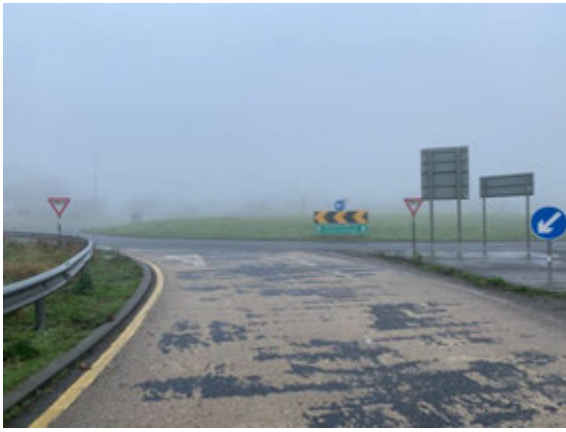
#### Location 2 - N29 / R711 Roundabout

Visual inspection indicates that road widening on the central island and the removal of several road signs will be required to accommodate loaded blade vehicles.

A topographical survey and swept path analysis is recommended at this location to confirm exact modifications required.

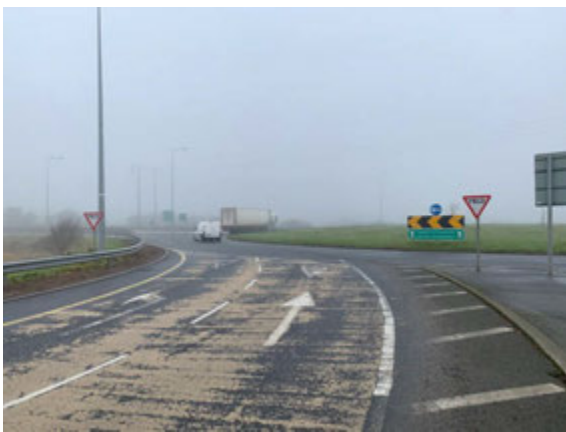
#### Location 3 - N29 / N25 Roundabout

Visual inspection indicates that road widening on the central island and the removal of several road signs will be required to accommodate loaded blade vehicles.

A topographical survey and swept path analysis is recommended at this location to confirm exact modifications required.

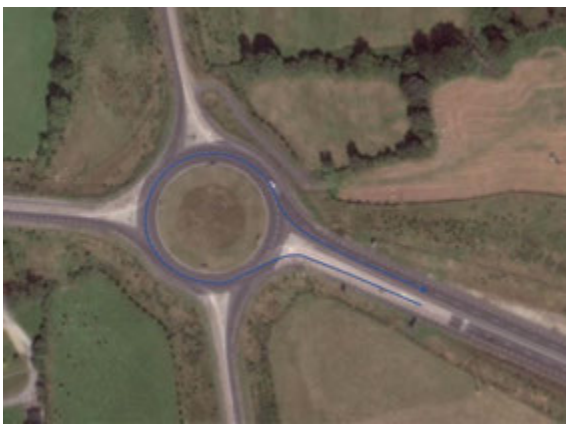
#### Location 4 - N25 Roundabout

Visual inspection indicates that road widening on the central island and the removal of several road signs will be required to accommodate loaded blade vehicles. Several lamp posts may also be affected by the blade vehicle and should be confirmed using Swept path analysis.

A topographical survey and swept path analysis is recommended at this location to confirm exact modifications required.

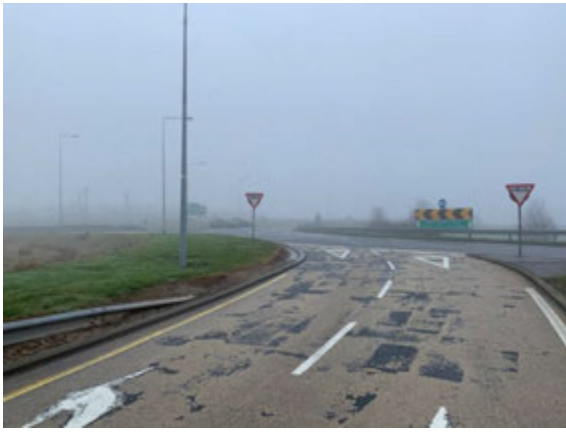
#### Location 5 - N25 / N24 Roundabout

Visual inspection indicates that loaded blade vehicle will require three lamp posts and one road sign to be removed from the nearside verge.

A topographical survey and swept path analysis is recommended at this location to confirm exact modifications required.

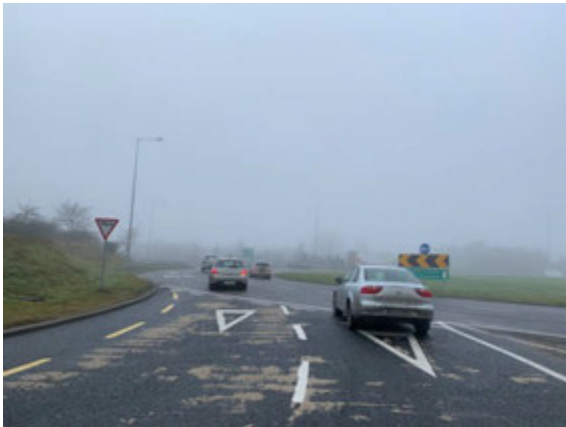
#### Location 6 - N24 / M9 Roundabout

Visual inspection indicates that road widening on the central island and the removal of several road signs will be required to accommodate loaded blade vehicles.

A topographical survey and swept path analysis is recommended at this location to confirm exact modifications required.

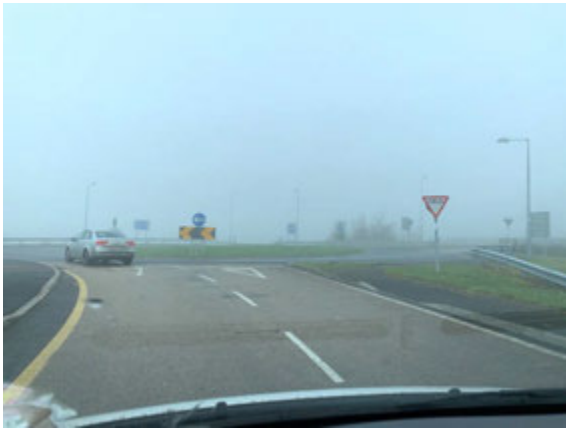
#### Location 7 - Exit M9 At Junction 11

Visual inspection indicates that loaded blade vehicles will contra flow the roundabout to minimise modifications required.

Road widening across central island and the offside pavement/verge will be required.

The safety barrier on the offside will require to be removed / realigned.

One lamp post on the nearside entry to roundabout will require removal.

Several road signs on both sides of the road and central / splitter islands will require removal.

A topographical survey and swept path analysis is recommended at this location to confirm exact modifications required.

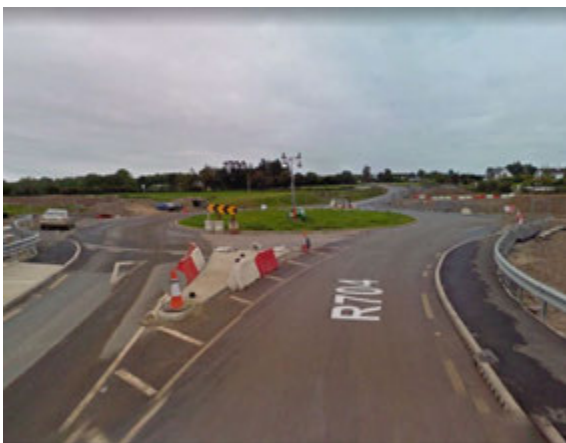
#### Location 8 - 2nd Roundabout Onto R704

Visual inspection indicates that loaded blade vehicles will contra flow the roundabout to minimise modifications required.

Road widening on the central island and the removal of a road sign will be required to accommodate loaded blade vehicles.

A topographical survey and swept path analysis is recommended at this location to confirm exact modifications required.

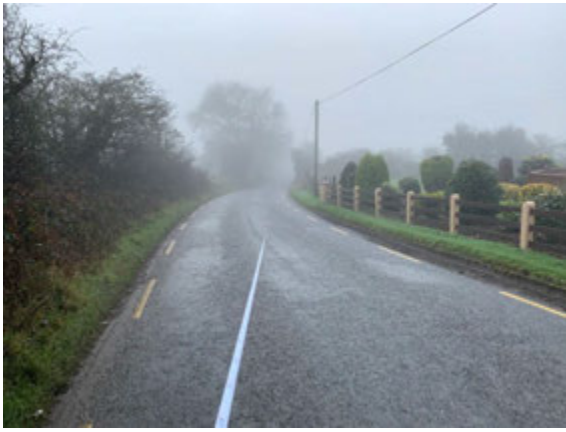
### Location 9 - R704 Left Hand Bend

Visual inspection indicates that tree pruning on the offside will be required to avoid damage to the blade tips.

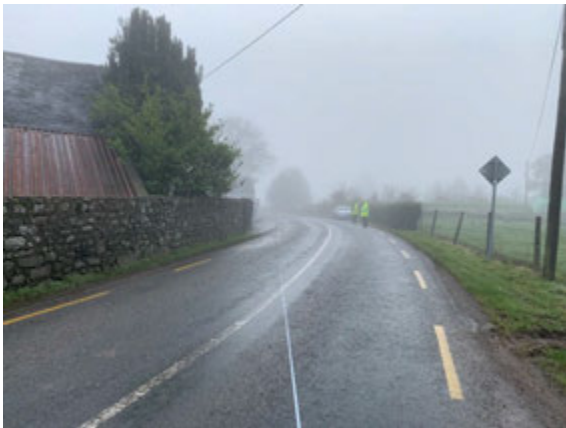
### Location 10 - R701 First Right Hand Bend

Visual inspection indicates that loaded blade vehicle will require third party land.

Road widening (Load bearing) will be required across the nearside highways verge and within third party land.

The telegraph pole and road sign will require removal / relocation.

A topographical survey and swept path analysis is recommended at this location to confirm exact modifications.

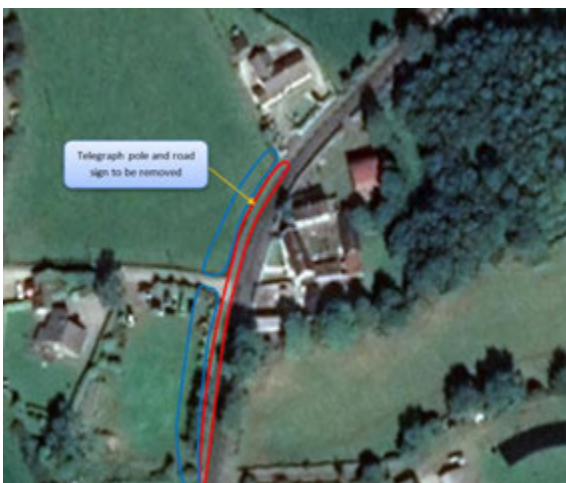
### Location 10 Continued - R704 First Right Hand Bend

Road widening (Load bearing) is required as indicated by the red outline.

Blade will oversail as indicated by blue outline.

Telegraph pole and road sign on nearside required to be removed.

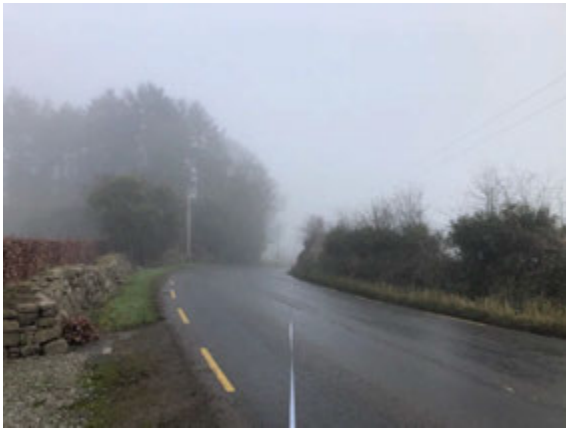
#### Location 11 - Second Right Hand Bend On R704

Visual inspection indicates that loaded blade vehicle will require third party land.

Road widening (Load bearing) will be required across the offside highways verge and within third party land.

A topographical survey and swept path analysis is recommended at this location to confirm exact modifications.

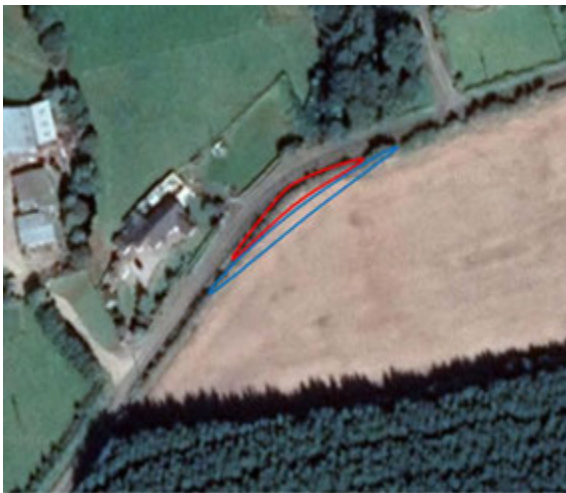
#### Location 11 Continued - Second Right Hand Bend On R704

Road widening (Load bearing) is required as indicated by the red outline.

Blade will oversail as indicated by blue outline.

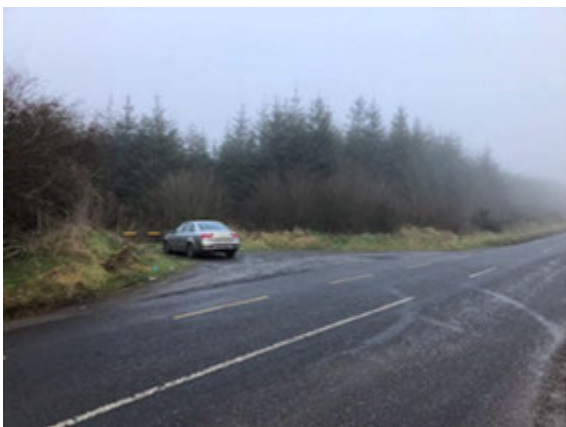
#### Location 12 - Site Entrance

Visual inspection indicates that a suitable site entrance will require to to be constructed to accommodate all loaded vehicles.

A topographical survey and swept path analysis is recommended at this location to confirm exact modifications required.
